River Mile 10.9 Removal Action – Steep Sloped Areas

PREPARED FOR: de maximis, inc.
COPY TO: File
PREPARED BY: CH2M HILL
DATE: September 26, 2013
PROJECT NUMBER: 474468.RA.PM.01

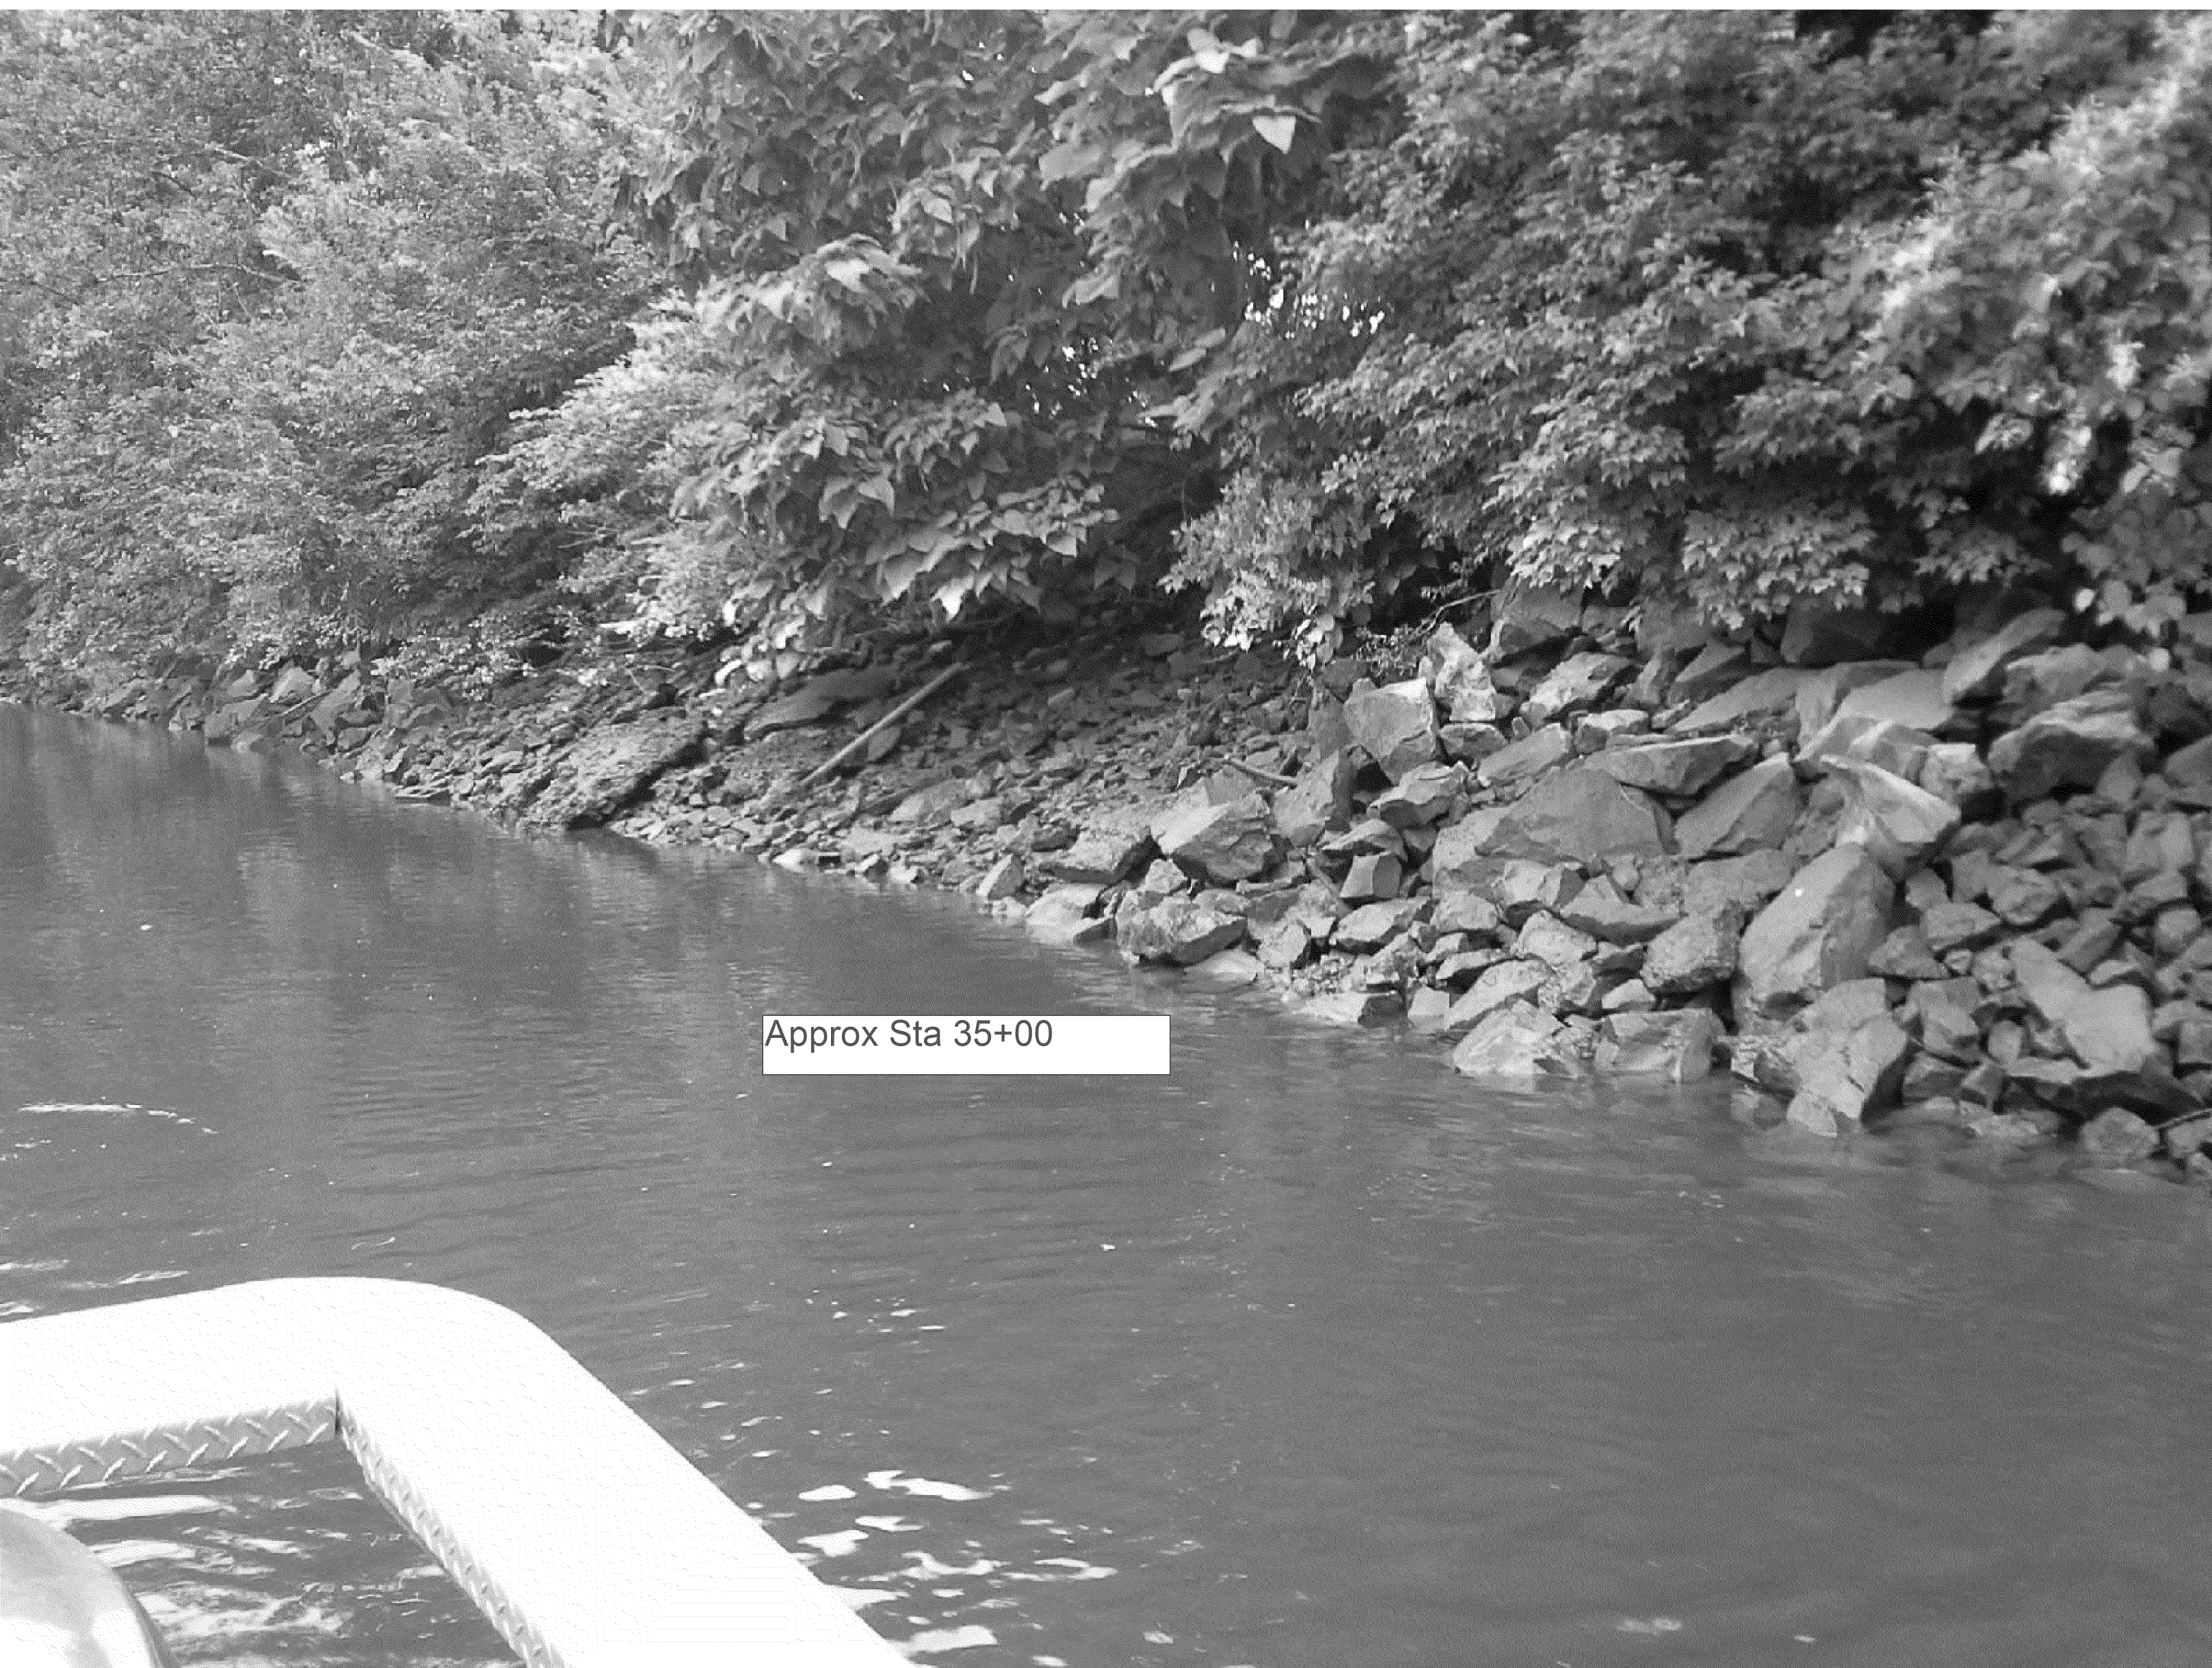
Attachment #1

Based on these findings it was determined that the majority of the Removal Area upriver of Station 29+50 will likely not be dredgeable because the steep slope is armored with rock. The rock armor appears to have been placed to prevent erosion of the steep shoreline and was found to extend from the shoreline to the toe of the slope. Significant soft sediment is not present along the armored slope and attempting to remove soft sediment from either the armored slope or at the toe of the slope could impact the integrity of the rock armor and destabilize the bank. The impacted area specific to Cut 10, with associated cross-sections, is provided as Attachment #2.

In order to prevent destabilizing the armored steep slope, it is recommended that the design be revised to eliminate dredging on the steep slope and that no dredging shall occur closer than 10 foot from the toe of the slope. The standard RM 10.9 cap will be placed from the toe of the slope to the edge of the navigation channel as well as areas that are not dredged and do not have a slope greater than 3H:1V (Station 29+50 to Station 30+50).
